I HNC - Summary of results

I HNC observations

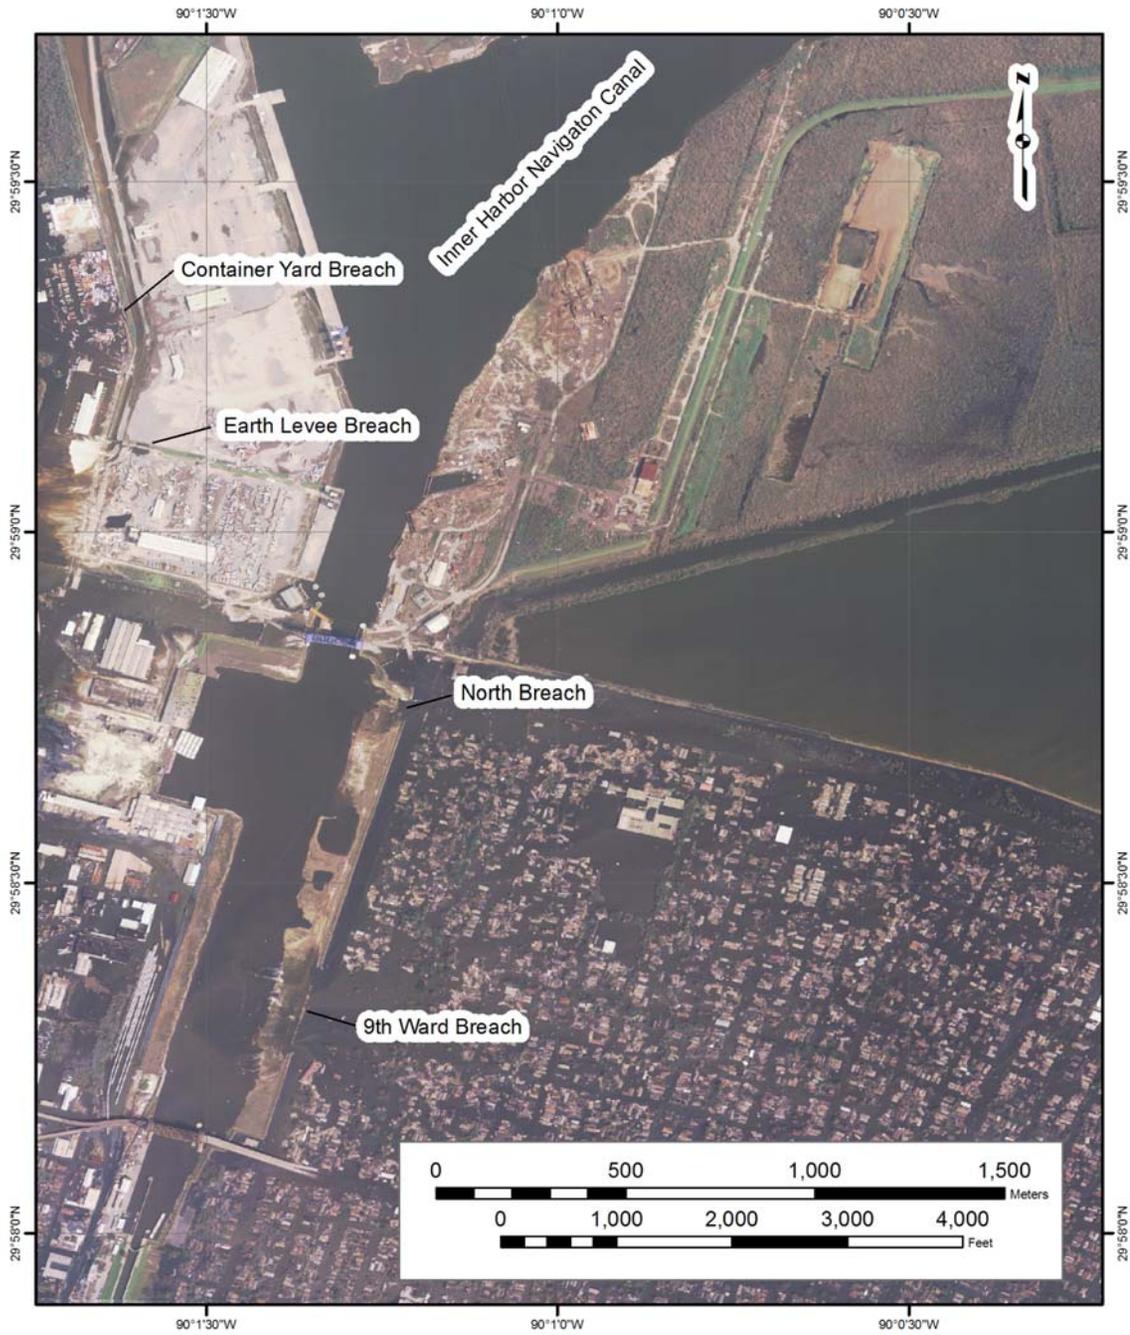
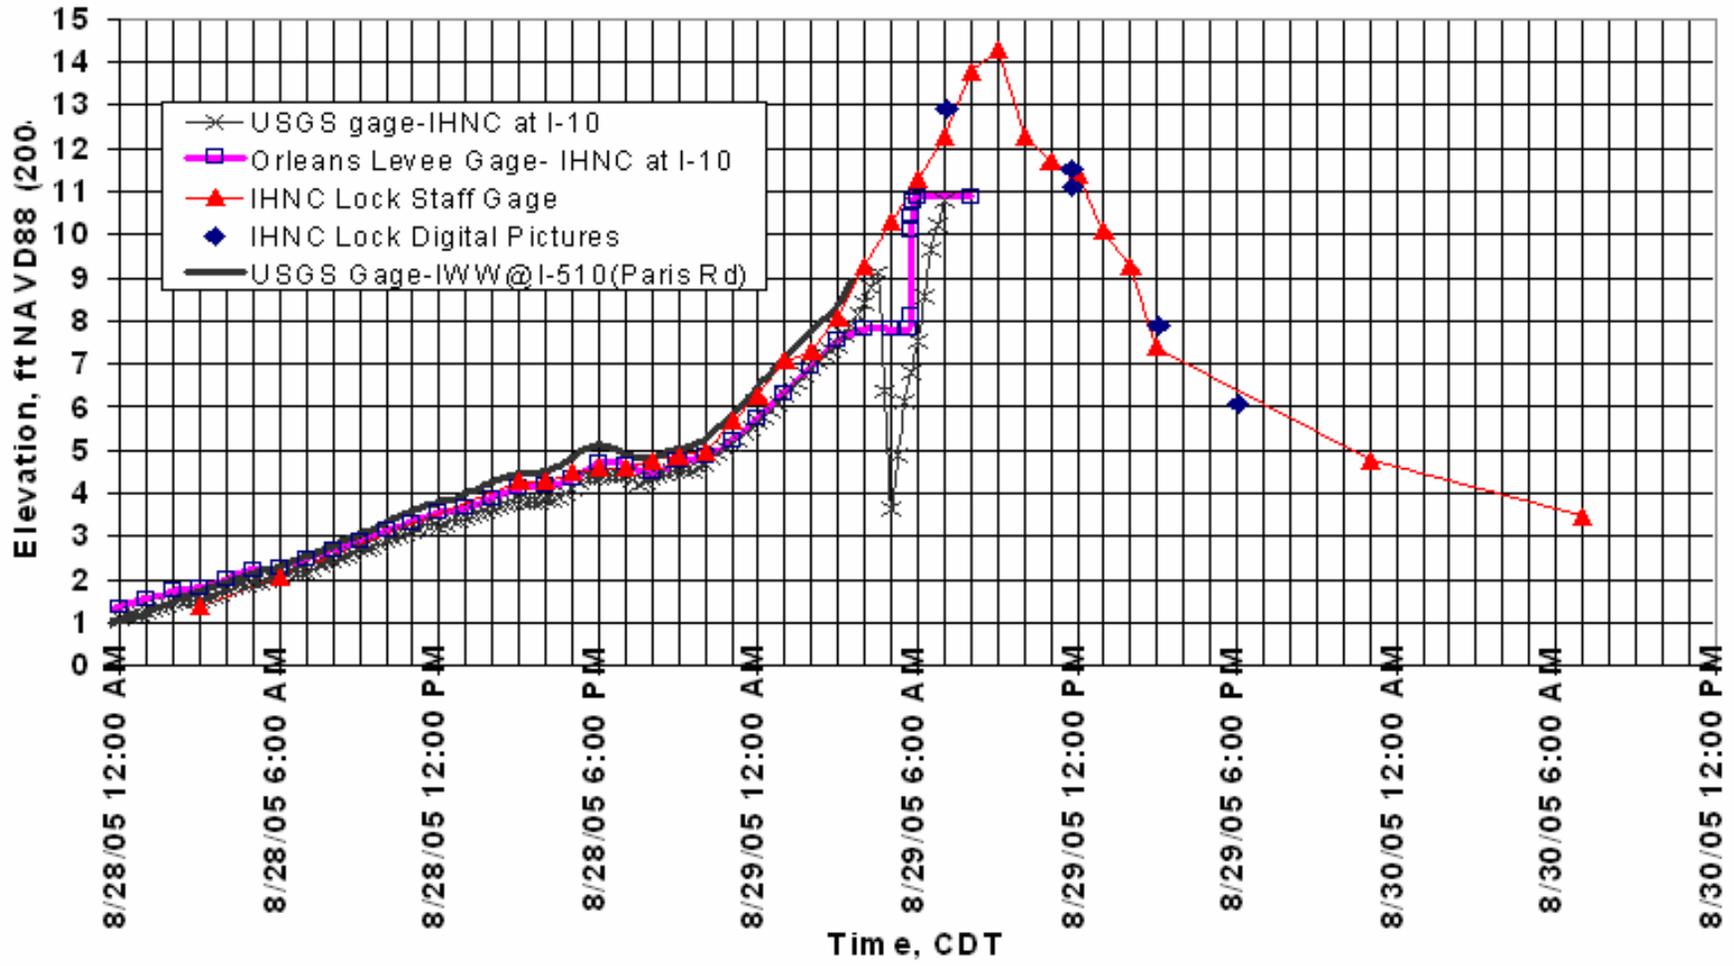
- Four breaches occurred on the I HNC – two east and two west
- All I HNC floodwalls were overtopped, by about 1.7 ft
- Water flowing over the tops of the walls eroded soil impairing the stability of the walls
- One of the breaches was due to erosion of a levee that was 2.5 ft lower than the floodwalls

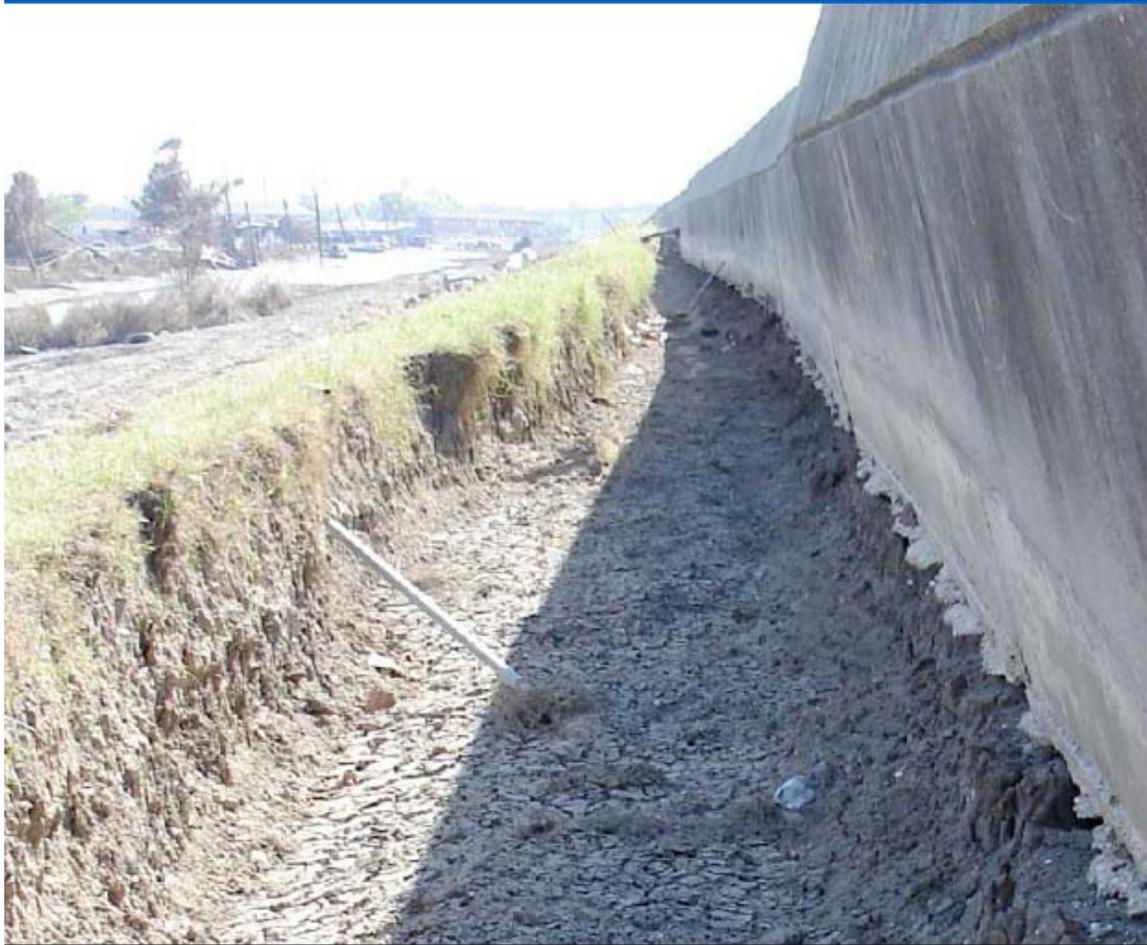
Erosion due to overtopping

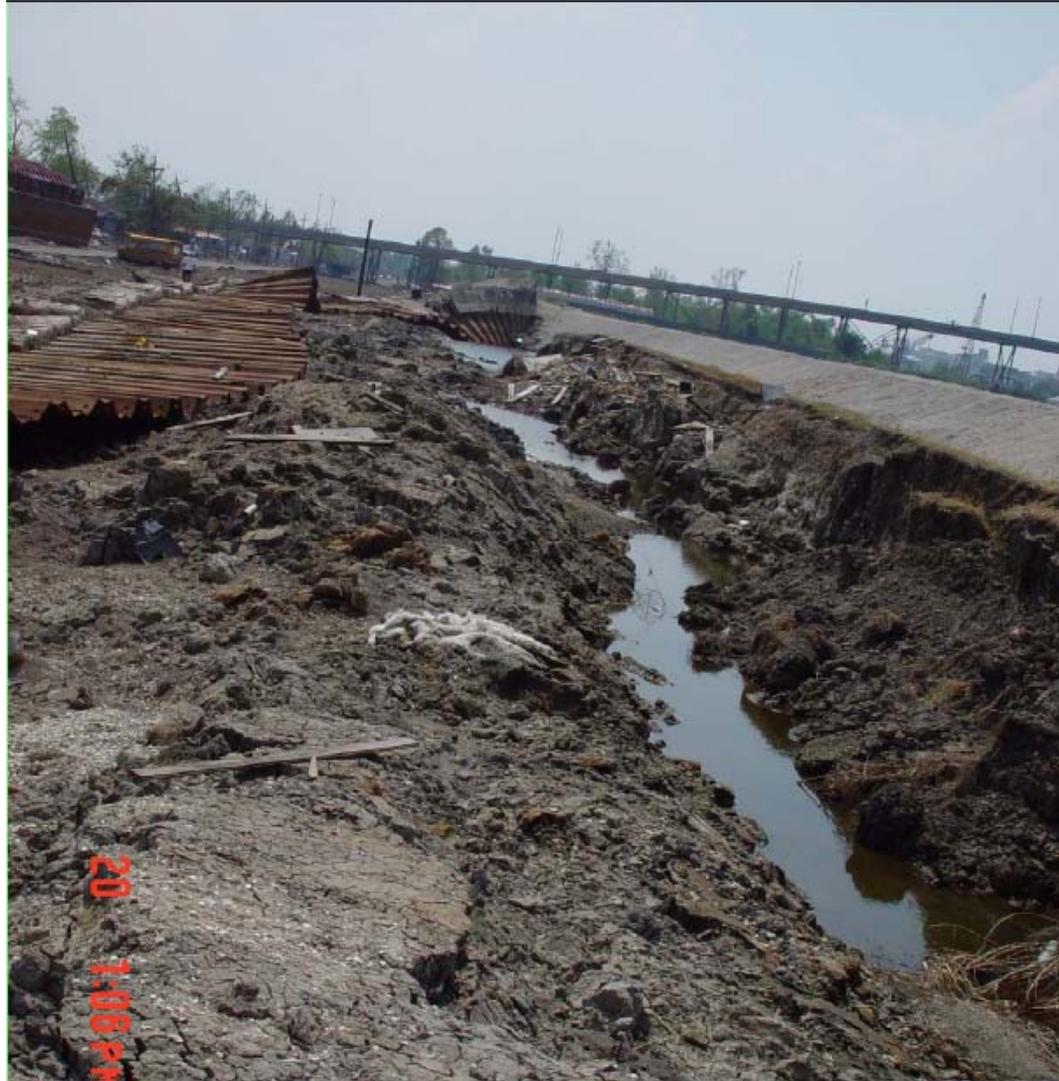
Erosion due to overtopping

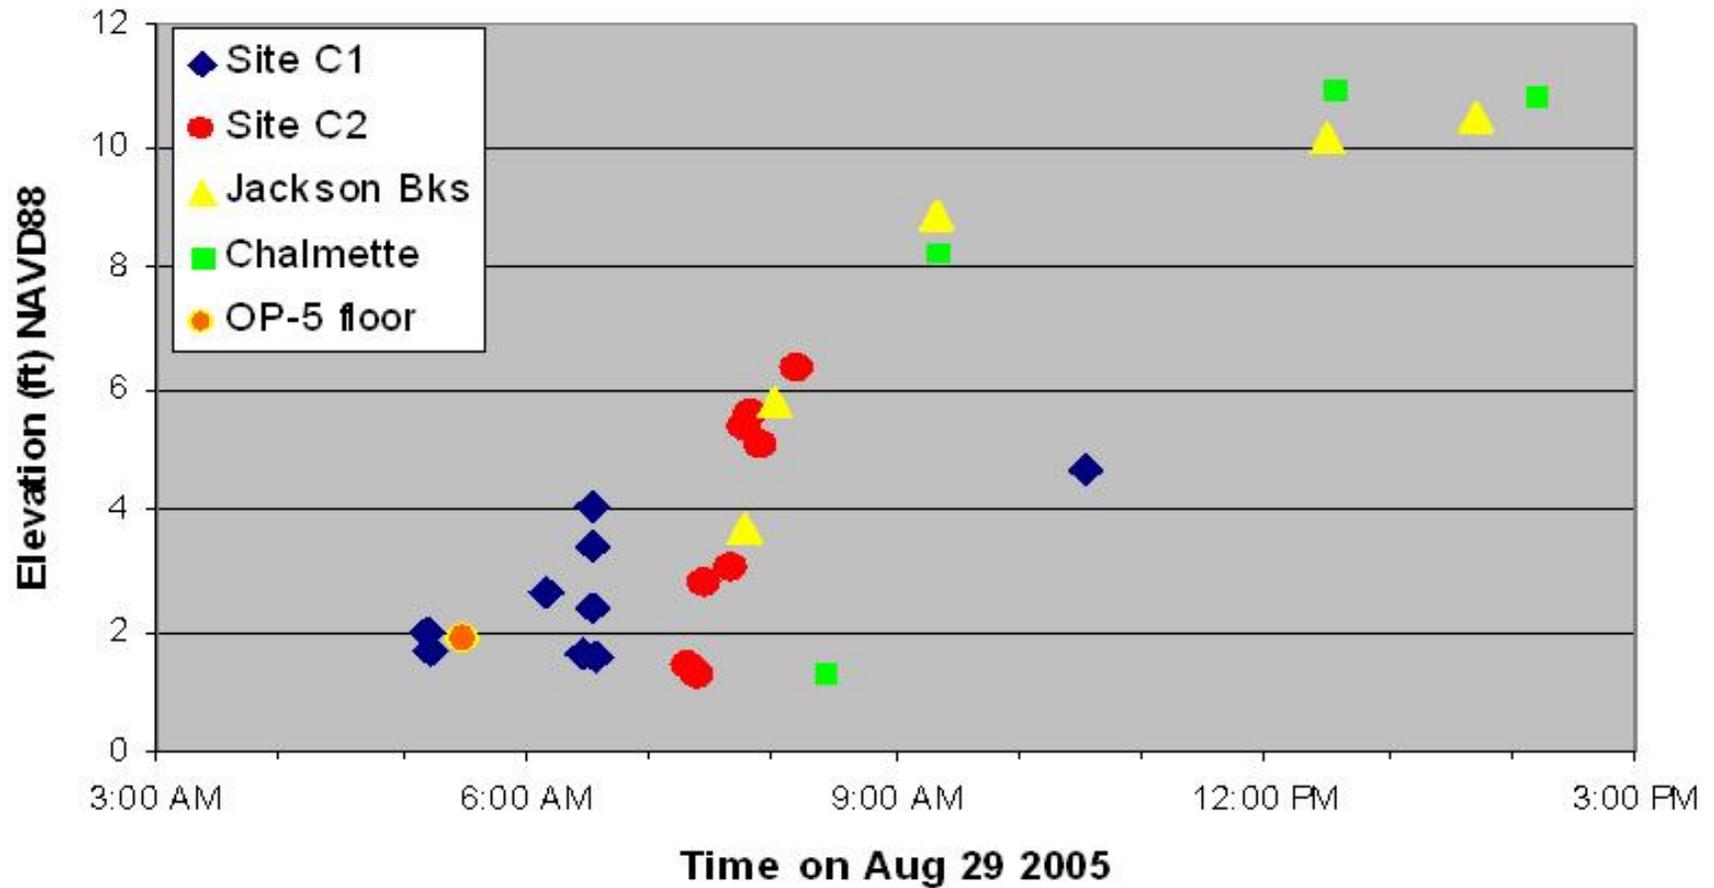
- Water was rising in the lower 9th Ward before overtopping
- At least one of the east side breaches must have occurred before overtopping

Provisional Stage Hydrographs Lower Ninth Ward and Chalmette
